## 2363 Deterioration

If you purchased your boiler before 2012, you most likely have the Monitor FCX boiler. On these boilers, there have been some issues with part #2363. This is the connecting piece between the condenser and the PP plastic stack. This piece is a welded assembly of thin stainless steel that is not totally resistant to the slight acidic content of the condensate. The time line of failure of this piece is not predictable. So at least once a year you should check all venting and in particularly this piece. On the new Geminox boilers this piece has been redesigned. It is now an assembly with a PP plastic core and an outer steel enclosure. Contact your supplier about a replacement.

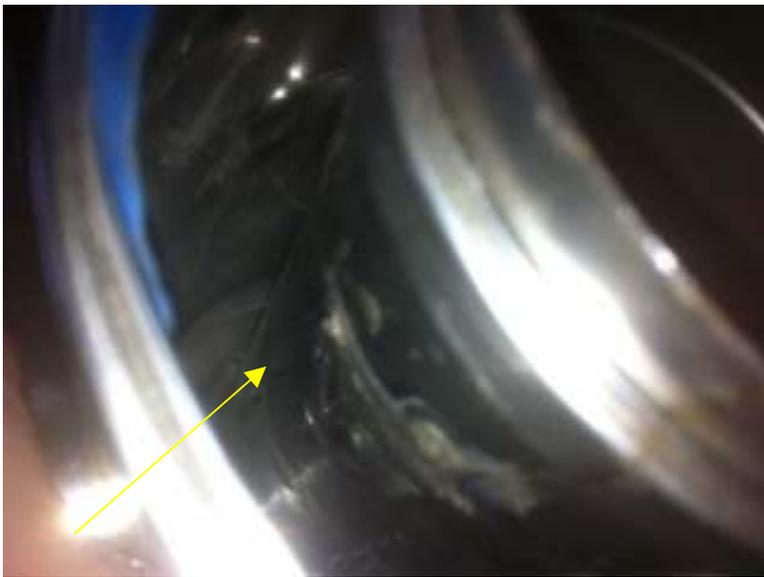
Slight discoloration of surface when pinholes first start

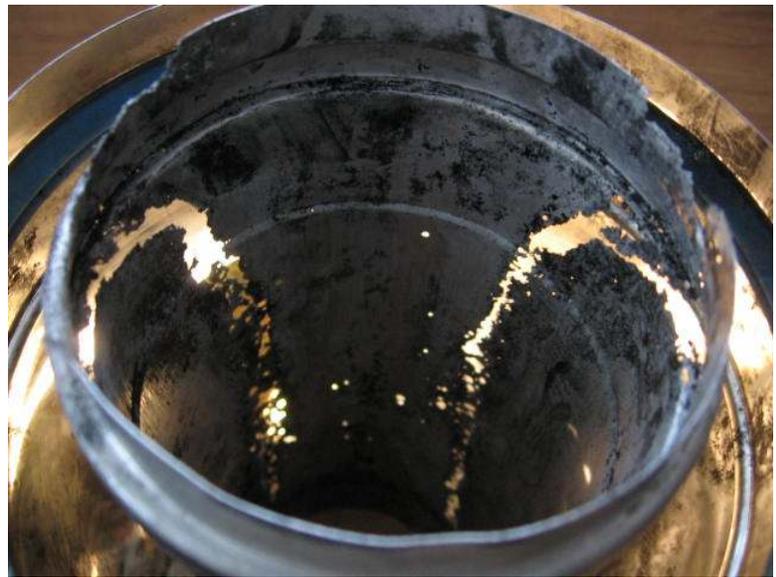
If you have a single pipe system and there is a hole in this piece, there is the potential for the leaking of flue gases into the room, and eventually condensate will leak through. In concentric flue system, it will begin to recirculate flue gases and condensate back through the burner and through the boiler. Because of the acidity of these gases it will eventually damage the boiler and the burner. This can be recognized by spots of white powder accumulating in the burner on the plastic and a discoloration of the metal parts. In the boiler, the residue of the debris can have a yellowish tinge and pasty in texture.

End result
