FCX 20 Part #2363

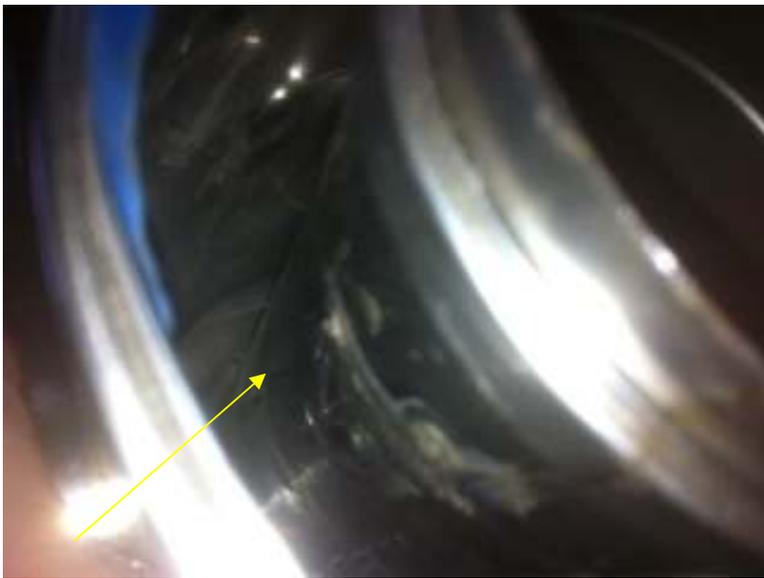
To inspect this part in a single pipe installation, you do not have to remove the flue. If your system is of the concentric type, you probably will. You need to be able to examine the outside of the inner pipe. You do not have to look at the inside of it. The following pictures show you what to look for:

Slight discoloration of surface when pinholes first start

If you purchased your boiler before 2012, you most likely have the Monitor branded FCX 20 boiler. On these boilers, there have been some concern with possible deterioration of part #2363. This is the connecting piece between the condenser and the PP plastic stack. This piece is a welded assembly of thin stainless steel that may not be totally resistant to the slight acidic content of the condensate. Whether or when this part may fail can not be predicted. So at least once a year you should check all venting and in particularly this piece. On the new Geminox boilers this piece has been redesigned. It is now an assembly with a PP plastic core and an outer steel enclosure. Contact your supplier about a replacement.

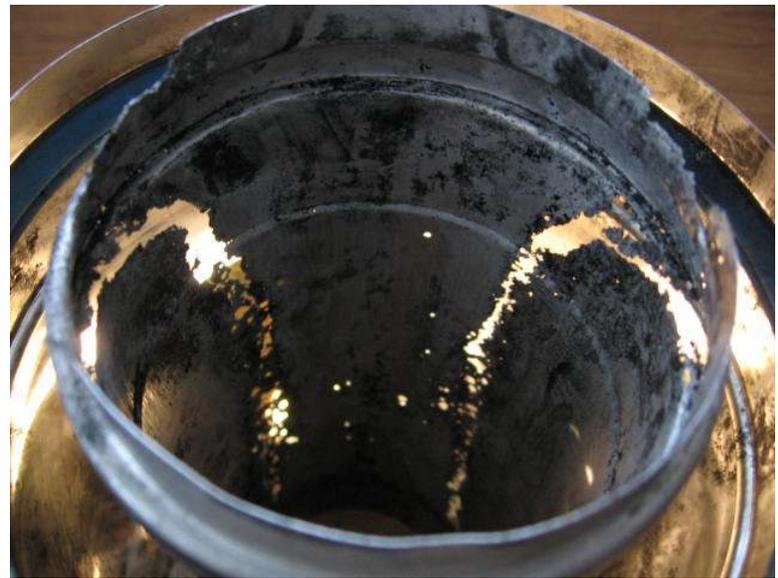
End result
